# Manhole Inspection Summary

Manhole # S13GG\_032MH

Insp Date: **2/23/09 11:47 AM**

**Location** Address: **REAR OF 2801 BAKER ST**

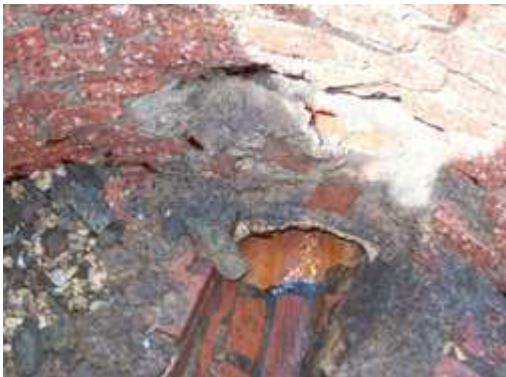
Defect 1

Condition: ☐ Sound ☐ Cracked ☐ Root Intrusion ☐ Loose Brick ☒ **Deteriorated**

Condition: ☐ Sound ☐ Cracked ☐ Root Intrusion ☐ Deteriorated ☐ Leaks ☒ **Debris**

debris in channel and deteriorated barrel

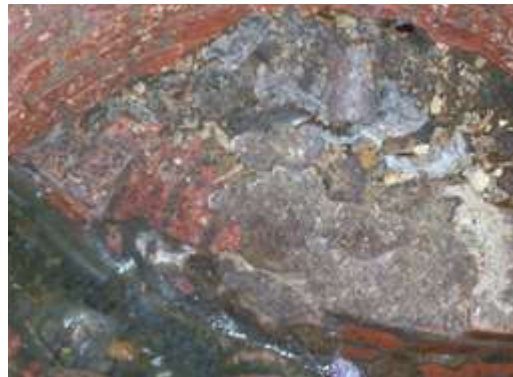
Defect 2

Condition: ☐ Sound ☐ Cracked ☐ Root Intrusion ☒ **Deteriorated** ☐ Leaks ☐ Debris

DETERATED BENCH

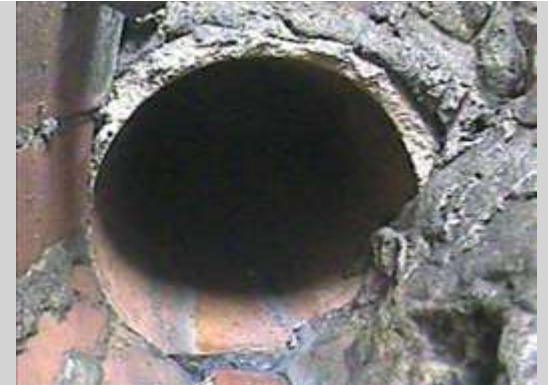
12 O'Clock Outflow

8 in. Circular Gravity Sewer  
Pipe Out @ 12 O'Clock

Infiltration: **None** Pipe Seal Cond: **Cracked**

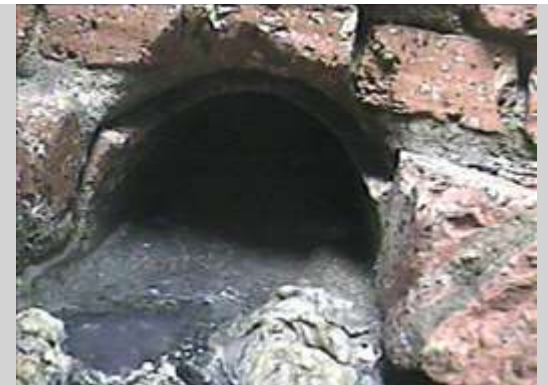
7 O'Clock Inflow

8 in. Circular Gravity Sewer  
Pipe In @ 7 O'Clock

Infiltration: **None** Pipe Seal Cond: **Broken**
